## **Site Visit Report - August 2021 - Armada 98/2 FPSO**

**Document No. S-BOB-01-REP-G-Z-034-B1-v3**

This report presents the findings of the Lender's Technical Advisor's (LTA) review of the progress of the construction of the Armada 98/2 FPSO in Sembcorp Tuas Boulevard shipyard including the inspection of the premises, offices, fabrication facilities and Ariake FPSO in the yard, carried out by Claude Rouxel, General Manager for Crandall Energy Asia Pacific, based in Singapore, on Thursday the 12th of August 2021.

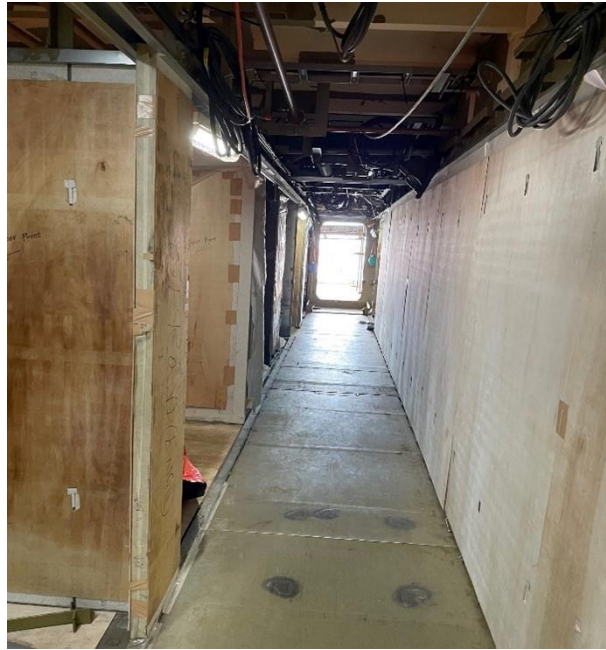
- Accommodation module painting at deck levels. Various outfitting work and panelling work in progress. EIT cabling ongoing. Installation of modular toilets, panel supports, profiles, insulation, wall panels, flooring, windows, steel doors, external stairs & handrails, pipe supports, telecom etc..;

**Figure 3-1 View inside the accommodation showing the panelling**

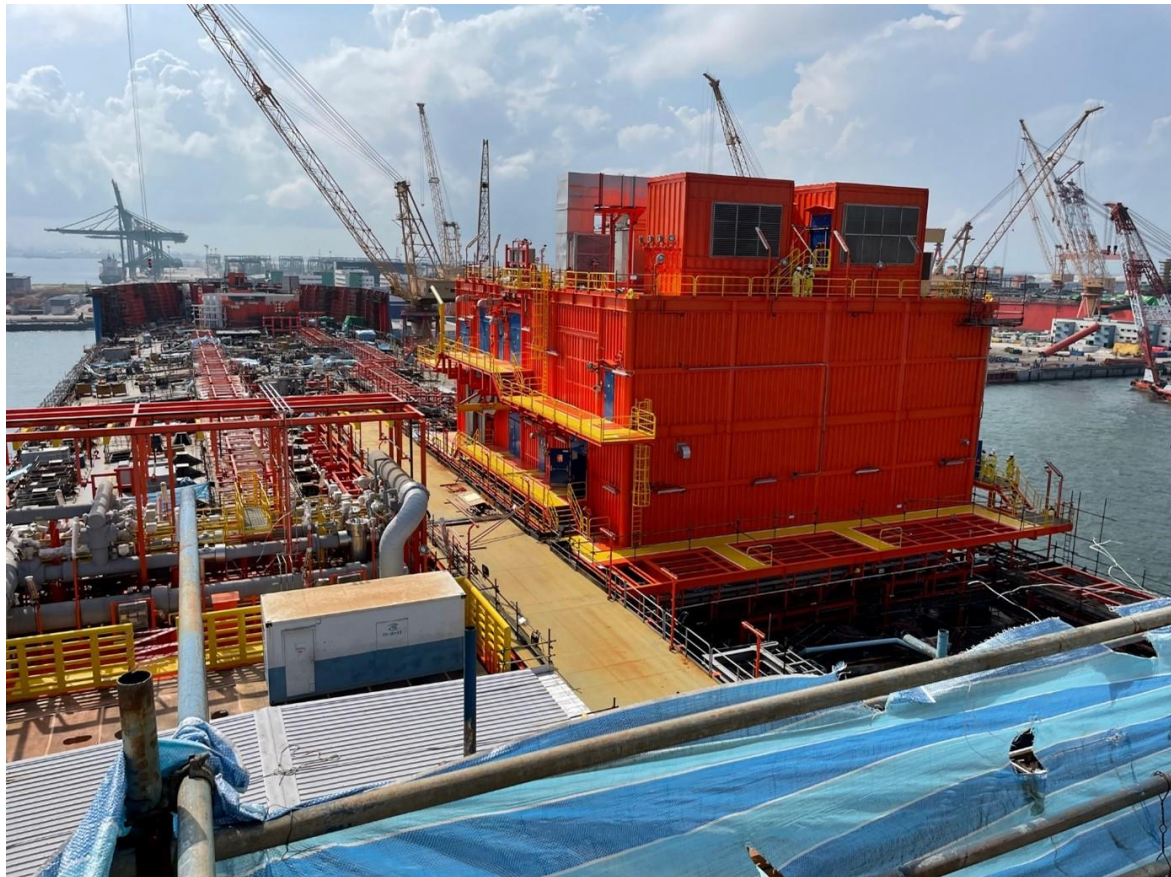
**Figure 3-2 Overall View of the deck showing the E-house, metering skid and TMS.**

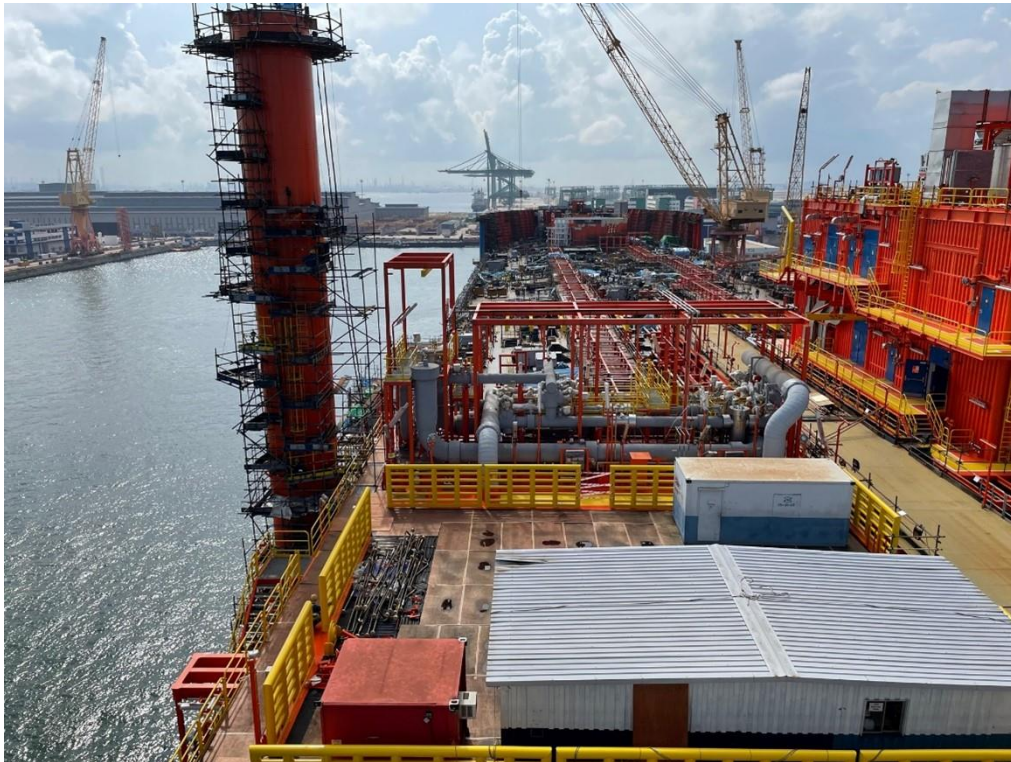
**Figure 3-3 Overview of the deck showing one pedestal crane and metering skid**

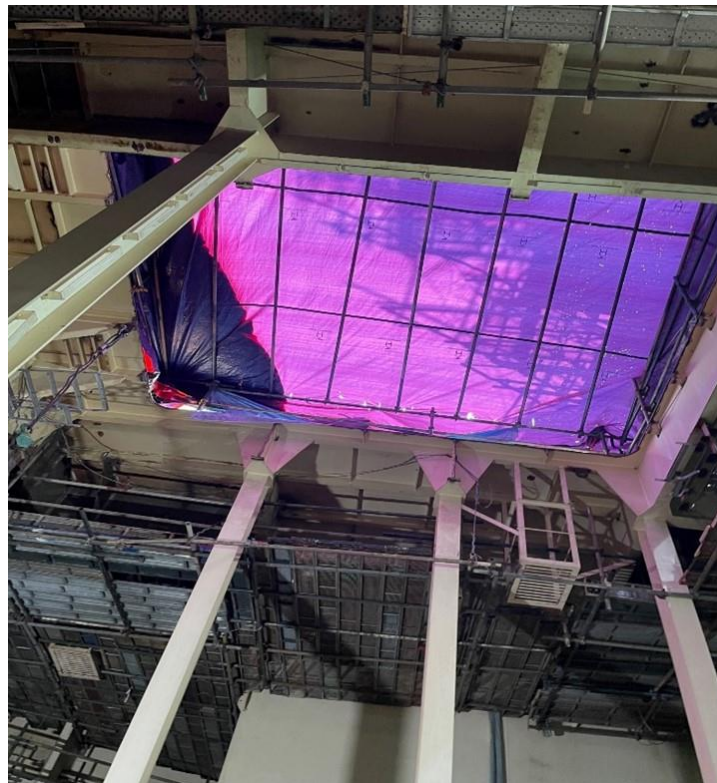
**Figure 3-4 View inside the engine room showing the hole in the deck used to lower down all equipment and that will be closed in the coming days.**

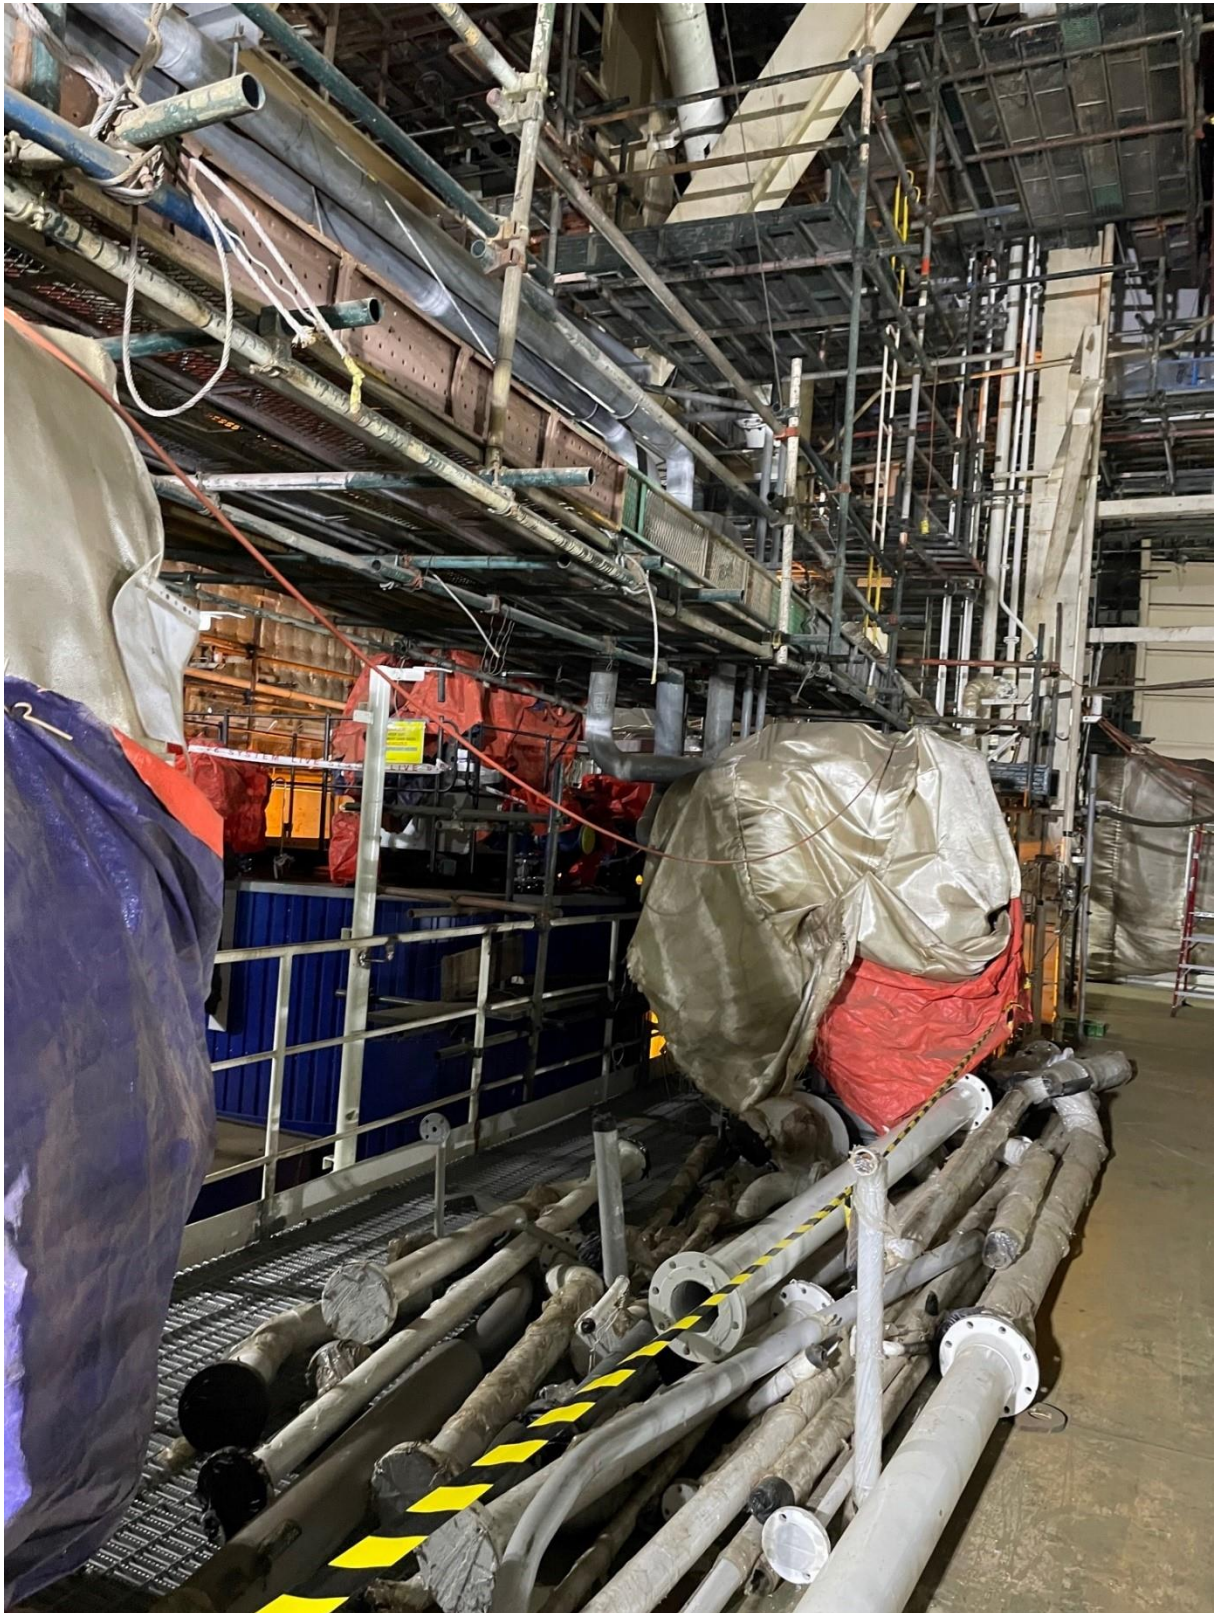
**Figure 3-5 View inside the engine room**

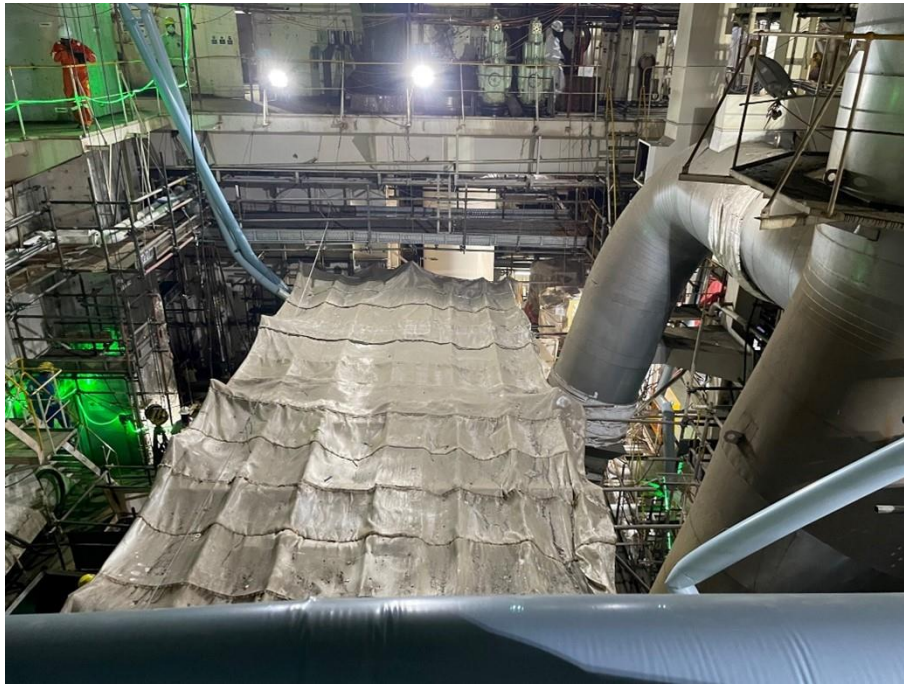
**Figure 3-6 Another view inside the engine room**

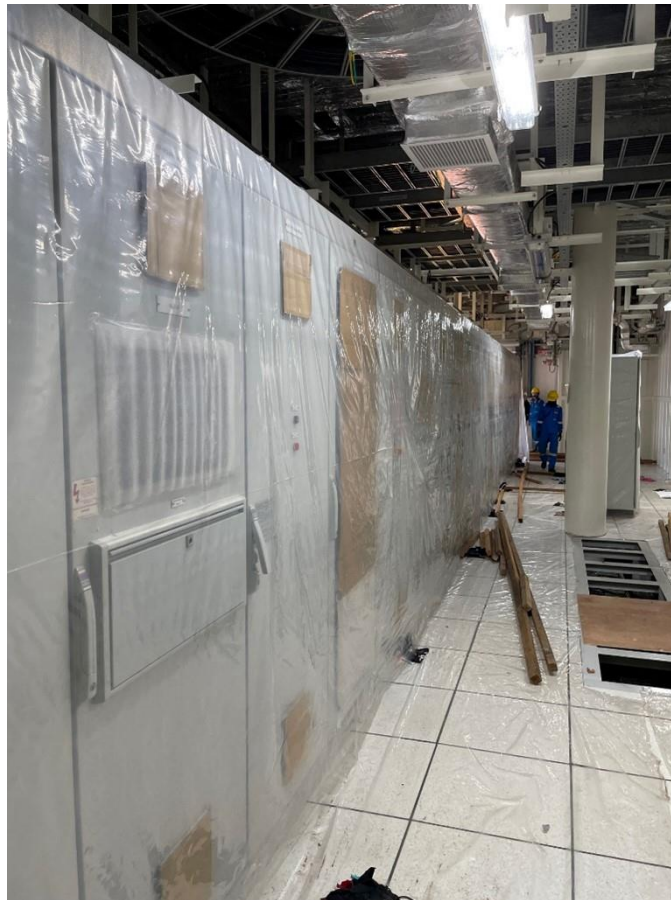
**Figure 3-7 View inside the E-house**

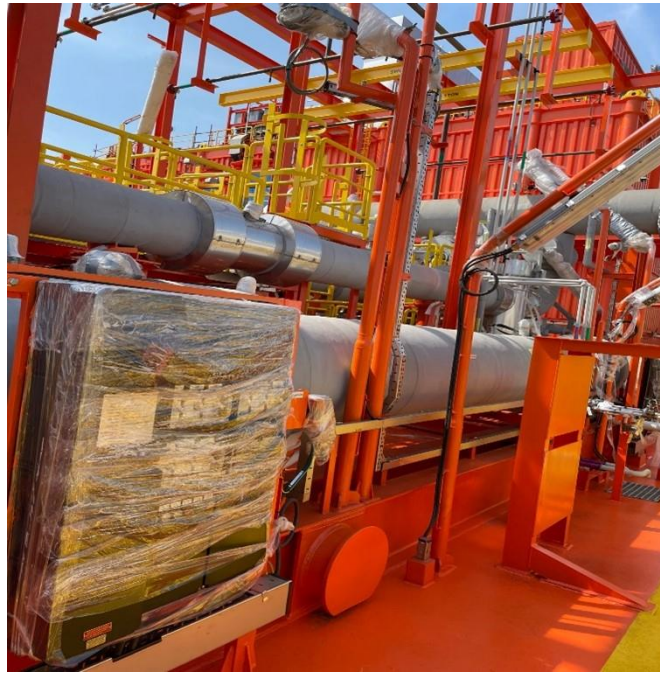
**Figure 3-8 Metering skid piping**

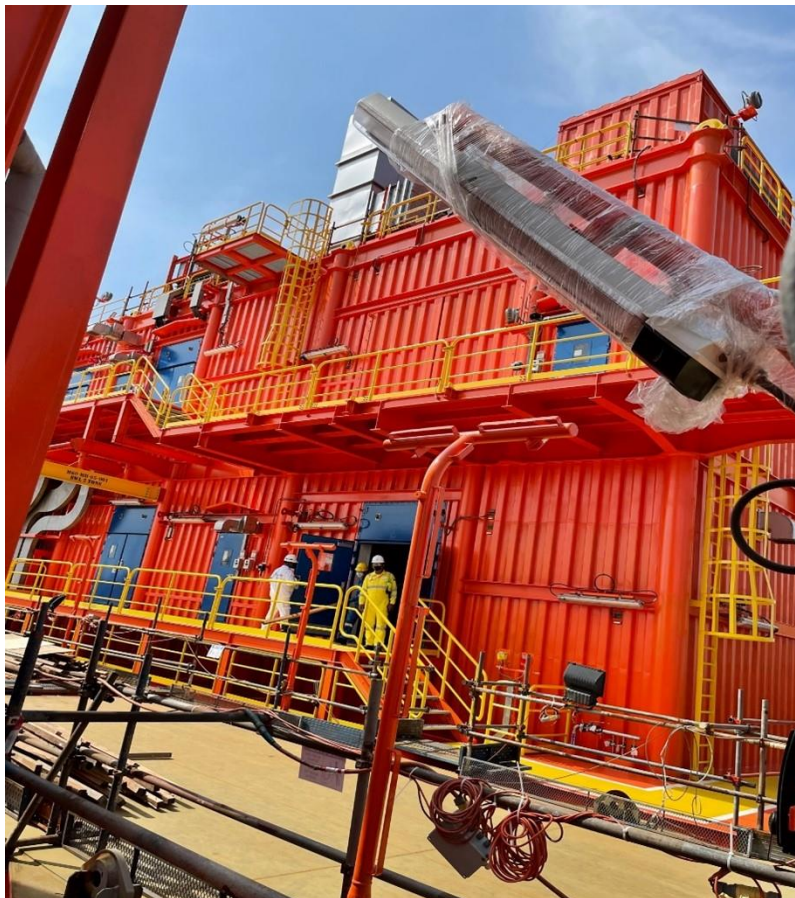
**Figure 3-9 View of Module M60 -E-house**

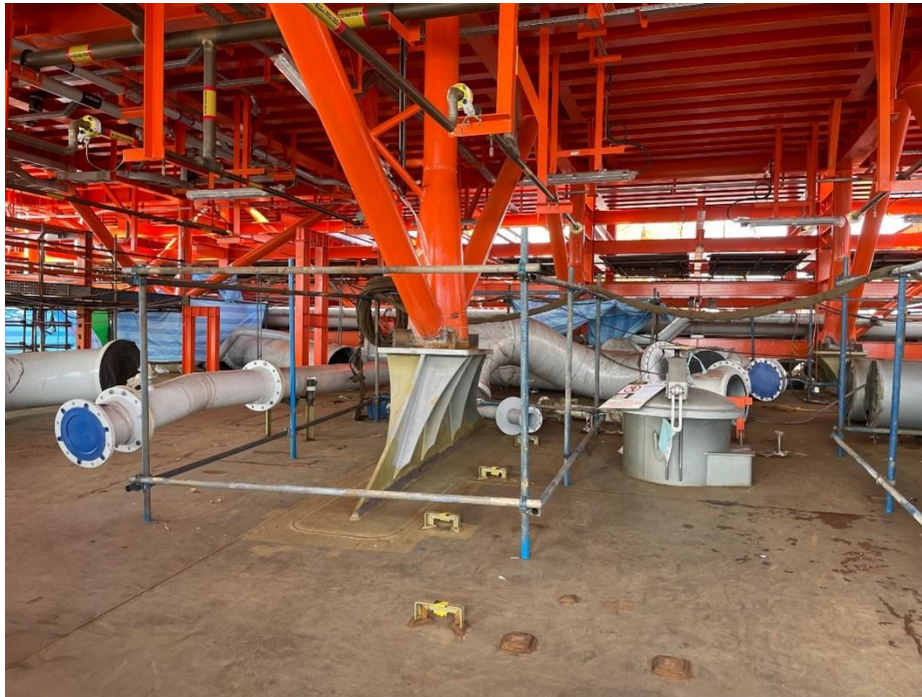
- M90 – Metering module. Integration nearly completed;
- Pipe rack under construction following load out and integration of modules;
- Cable racks installation completed;

**Figure 3-10 Underdeck view of Module M90 – metering skid**

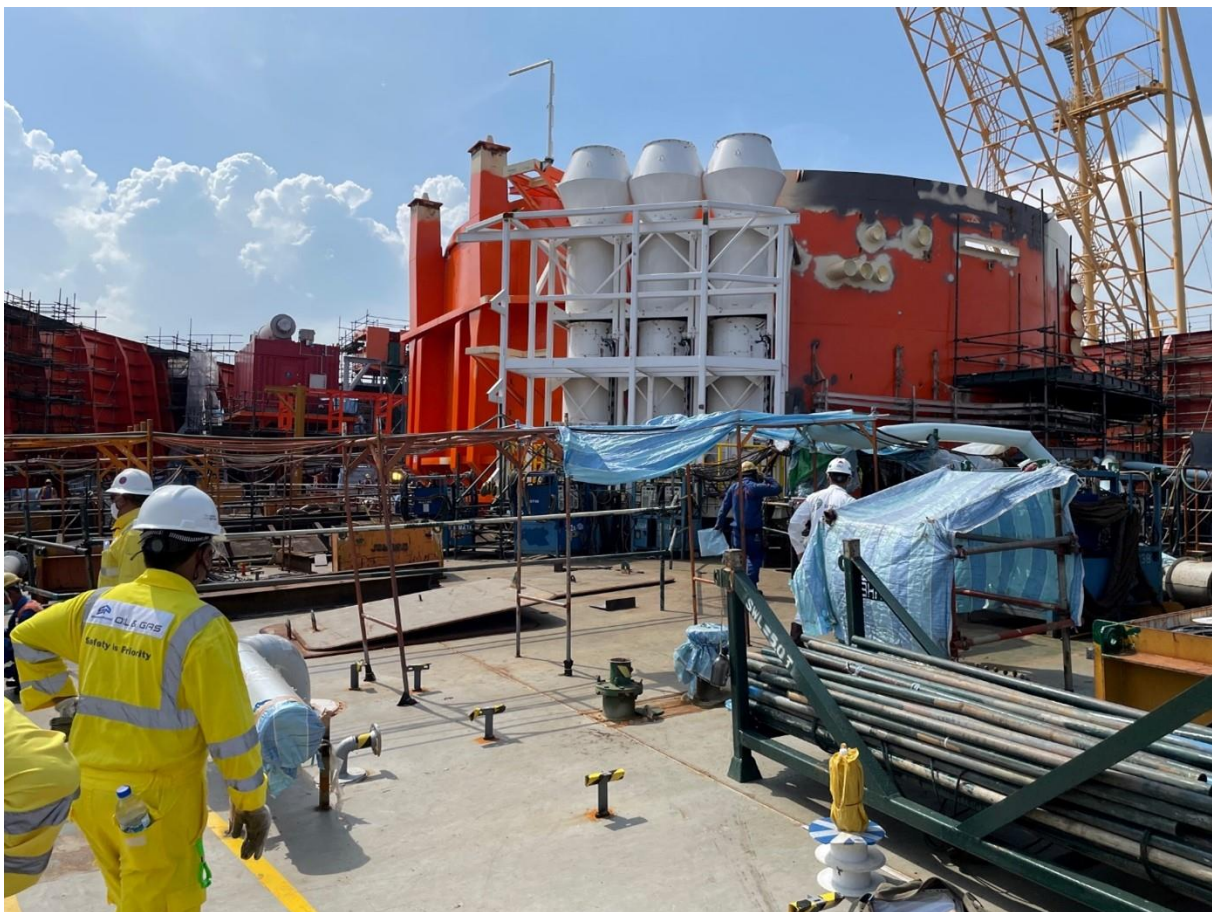
- TMS – Turret cylinder integrated and painted, waiting for Geo Stationery Module (GSM);
- Helideck, painted, ready for installation;
- For the Engine Room / Pump Room, piping and equipment installation is in progress. Installation of pumps & motors is ongoing. Shop fabrication & installation on board of renewal spools for various piping systems is in progress. Conversion spools fabrication and installation are also in progress. Various system valves installation is in progress. In CCR, EIT Cabinets are in progress of installation.

**Figure 3-11 View of TMS cylinder**

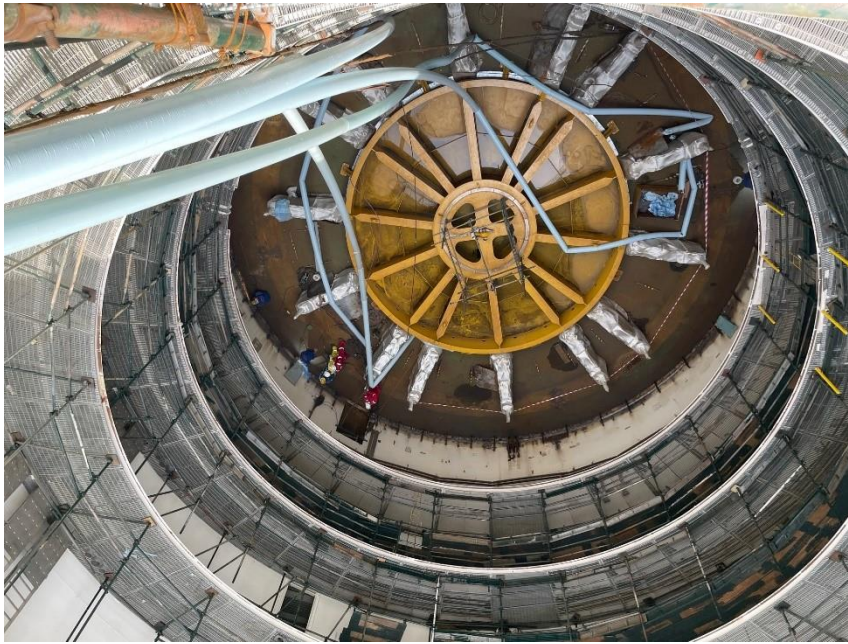
**Figure 3-12 Inside view of Turret cylinder showing connector at the bottom**

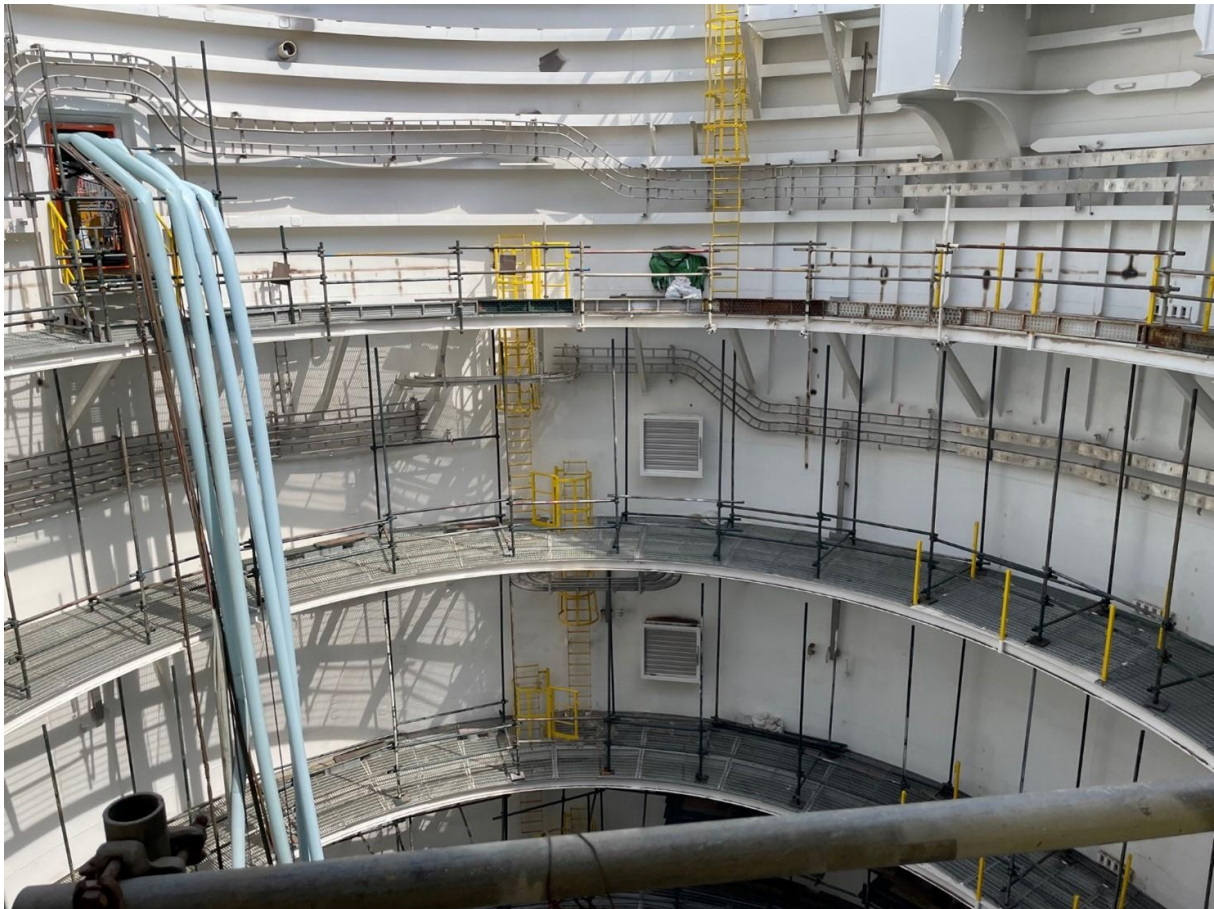
**Figure 3-13 View inside the TMS**

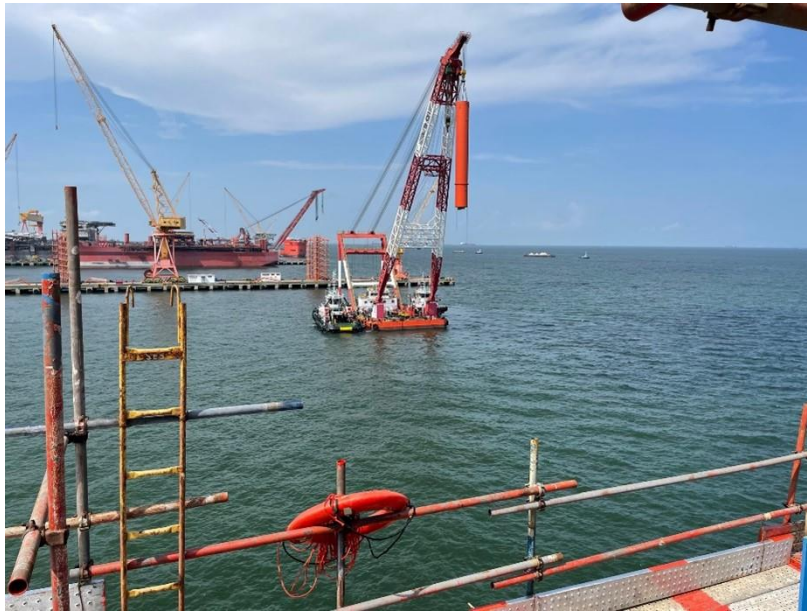
**Figure 3-14 Crane pedestal ready for installation on deck**

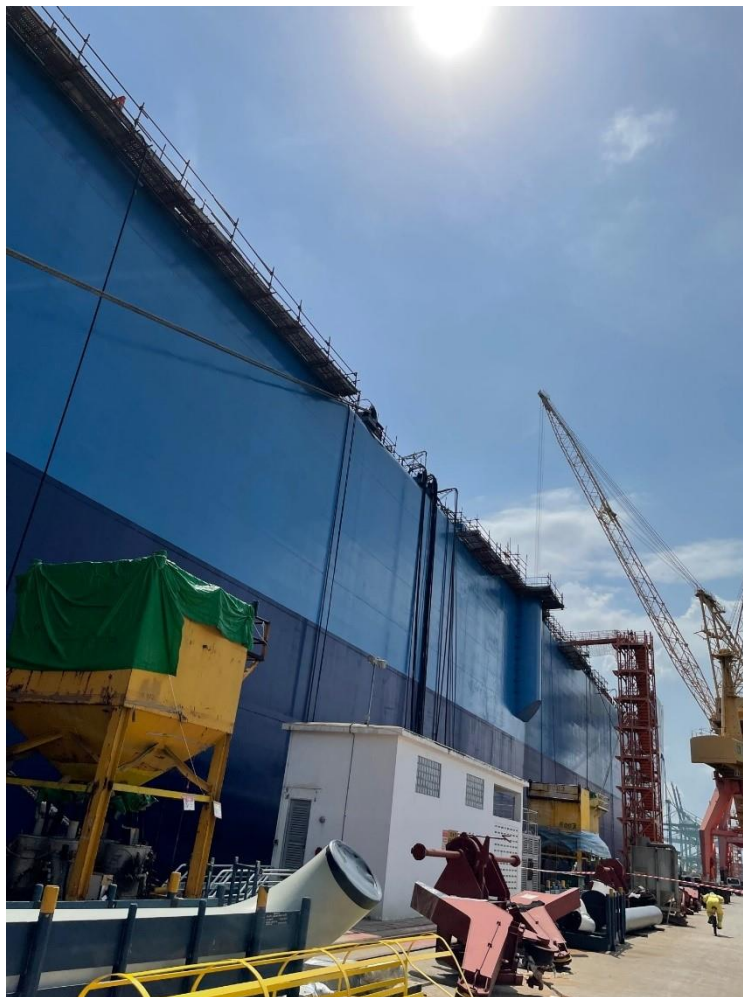
**Figure 3-15 Side view showing where the crane will be installed**

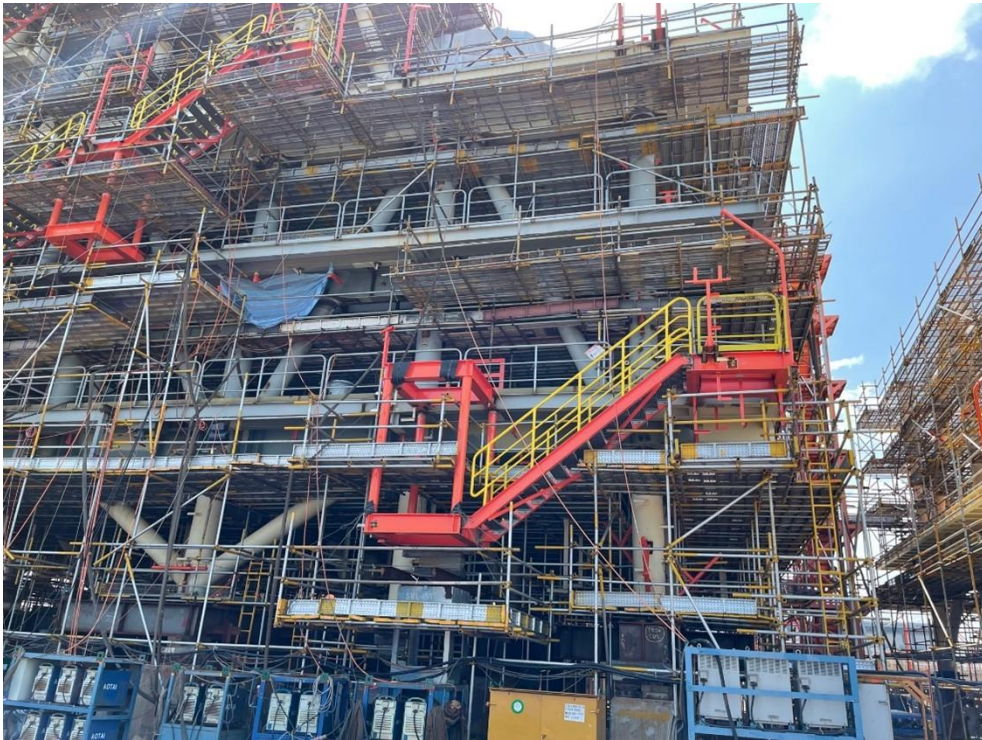
- M30 – Module nearly completed. Structural Box Up completed. Piping Spools fabrication in progress. Equipment installation ongoing;
- M60 – E House – Loadout completed, integration ongoing;

**Figure 3-16 Overall view of Module M-30**

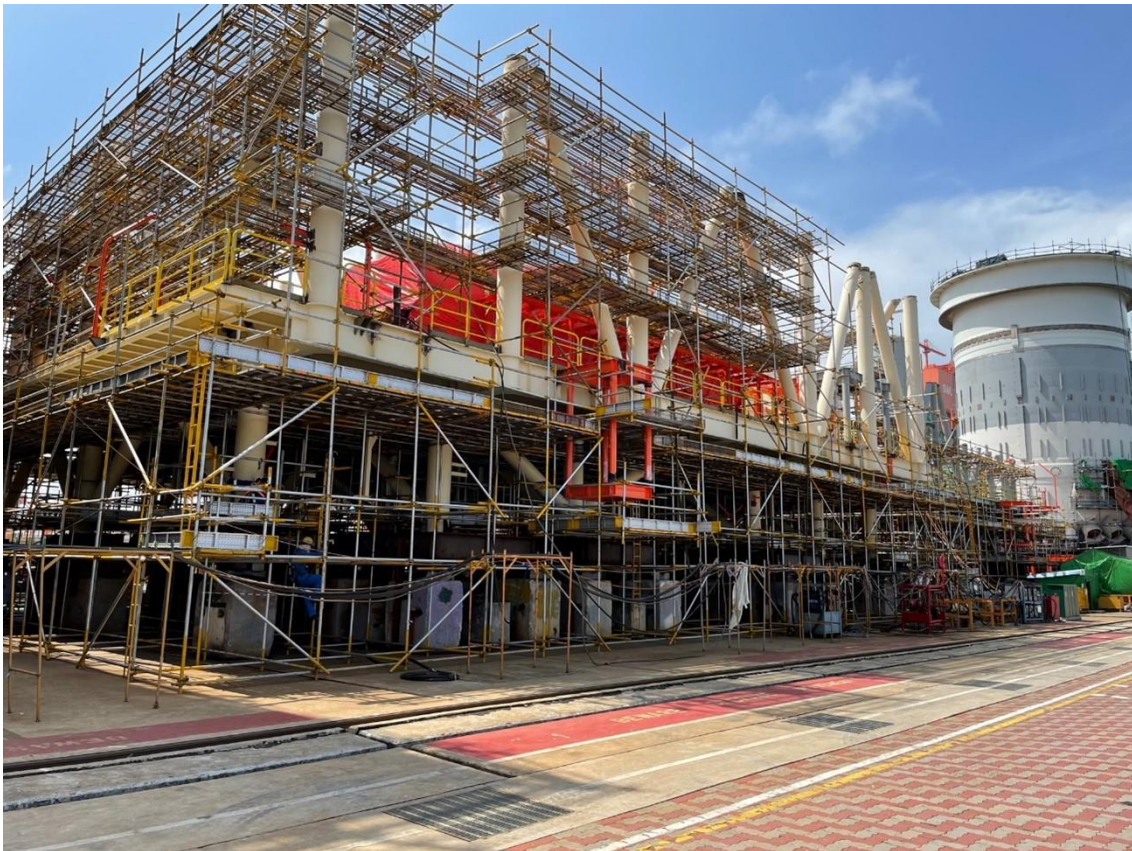
- M31 – Booster export gas compressor Train A installed. All decks fabrication completed. Fabrication and installation of remaining pipe spools, pipe supports and outfitting ongoing. Module well progressed;

**Figure 3-17 Overall view of Module M31**

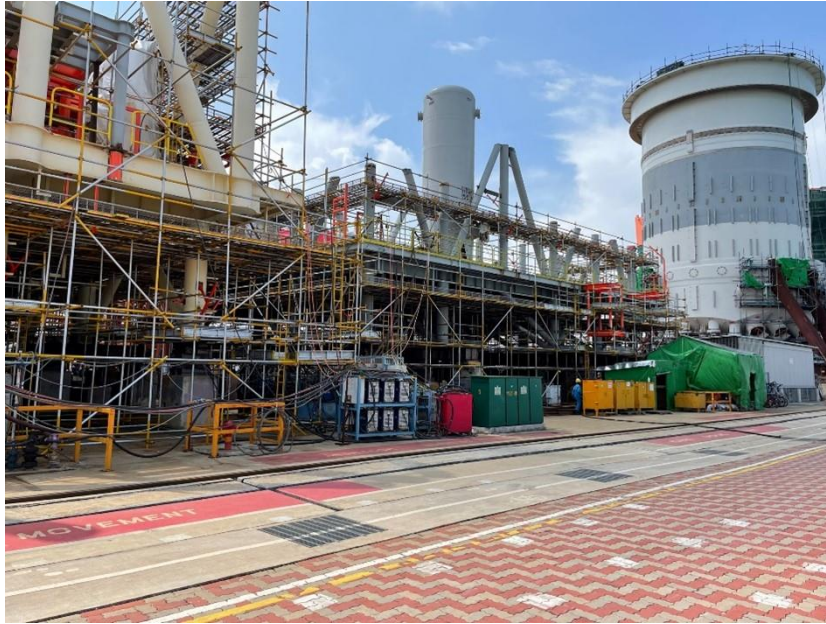
- M20 – Gas Lift Compressor Train A installed. Pipe spool fabrication ongoing and E&I equipment and cable tray installation. Intermediate decks already constructed;

**Figure 3-18 Overall view of Module M-20**

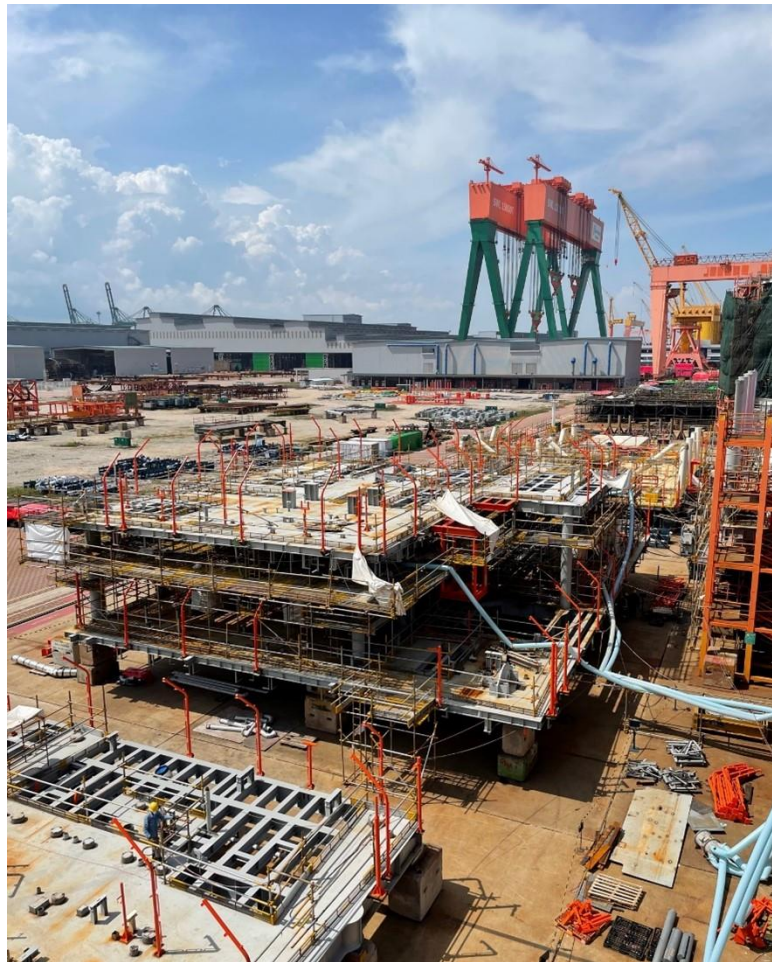
**Figure 3-19 Decks already built, ready to be installed on top of M20 & 31**

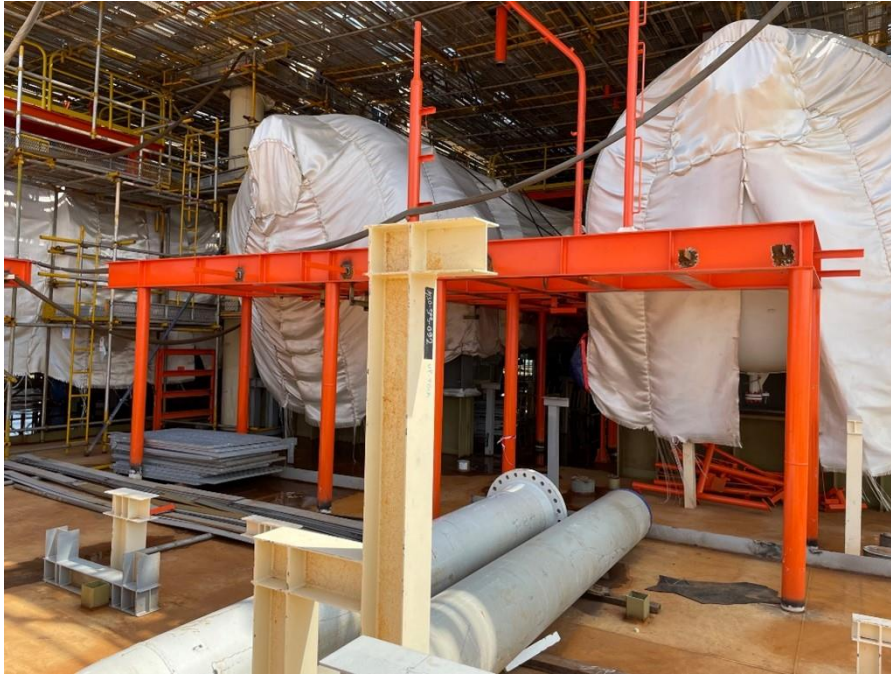
**Figure 3-20 Inside view M30**

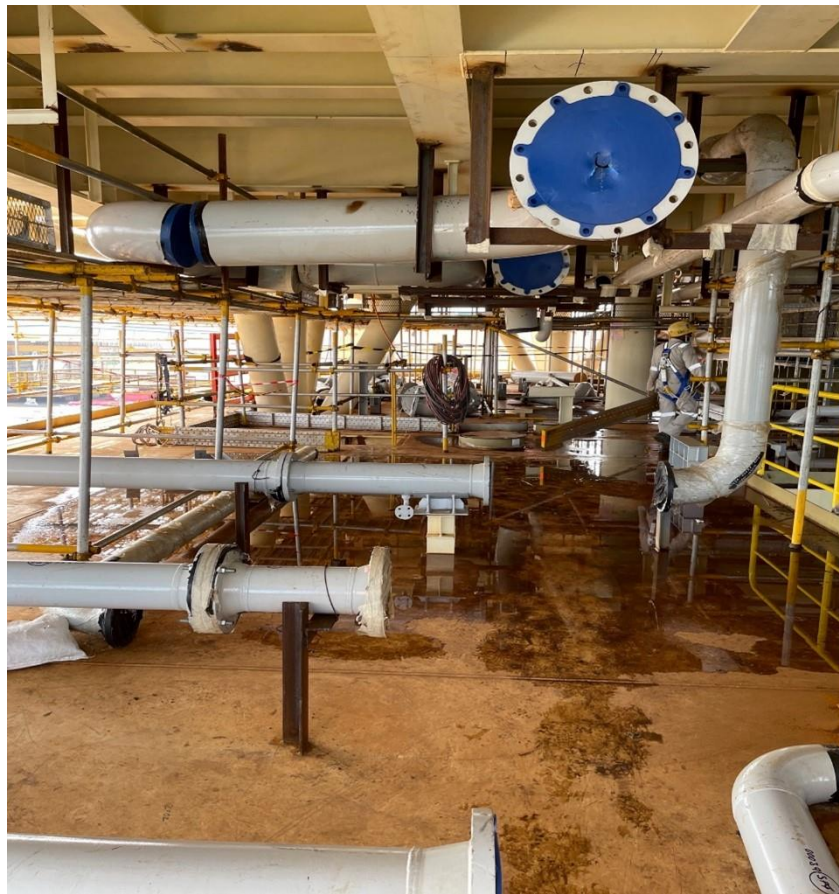
**Figure 3-21 Another inside view of Module M30**

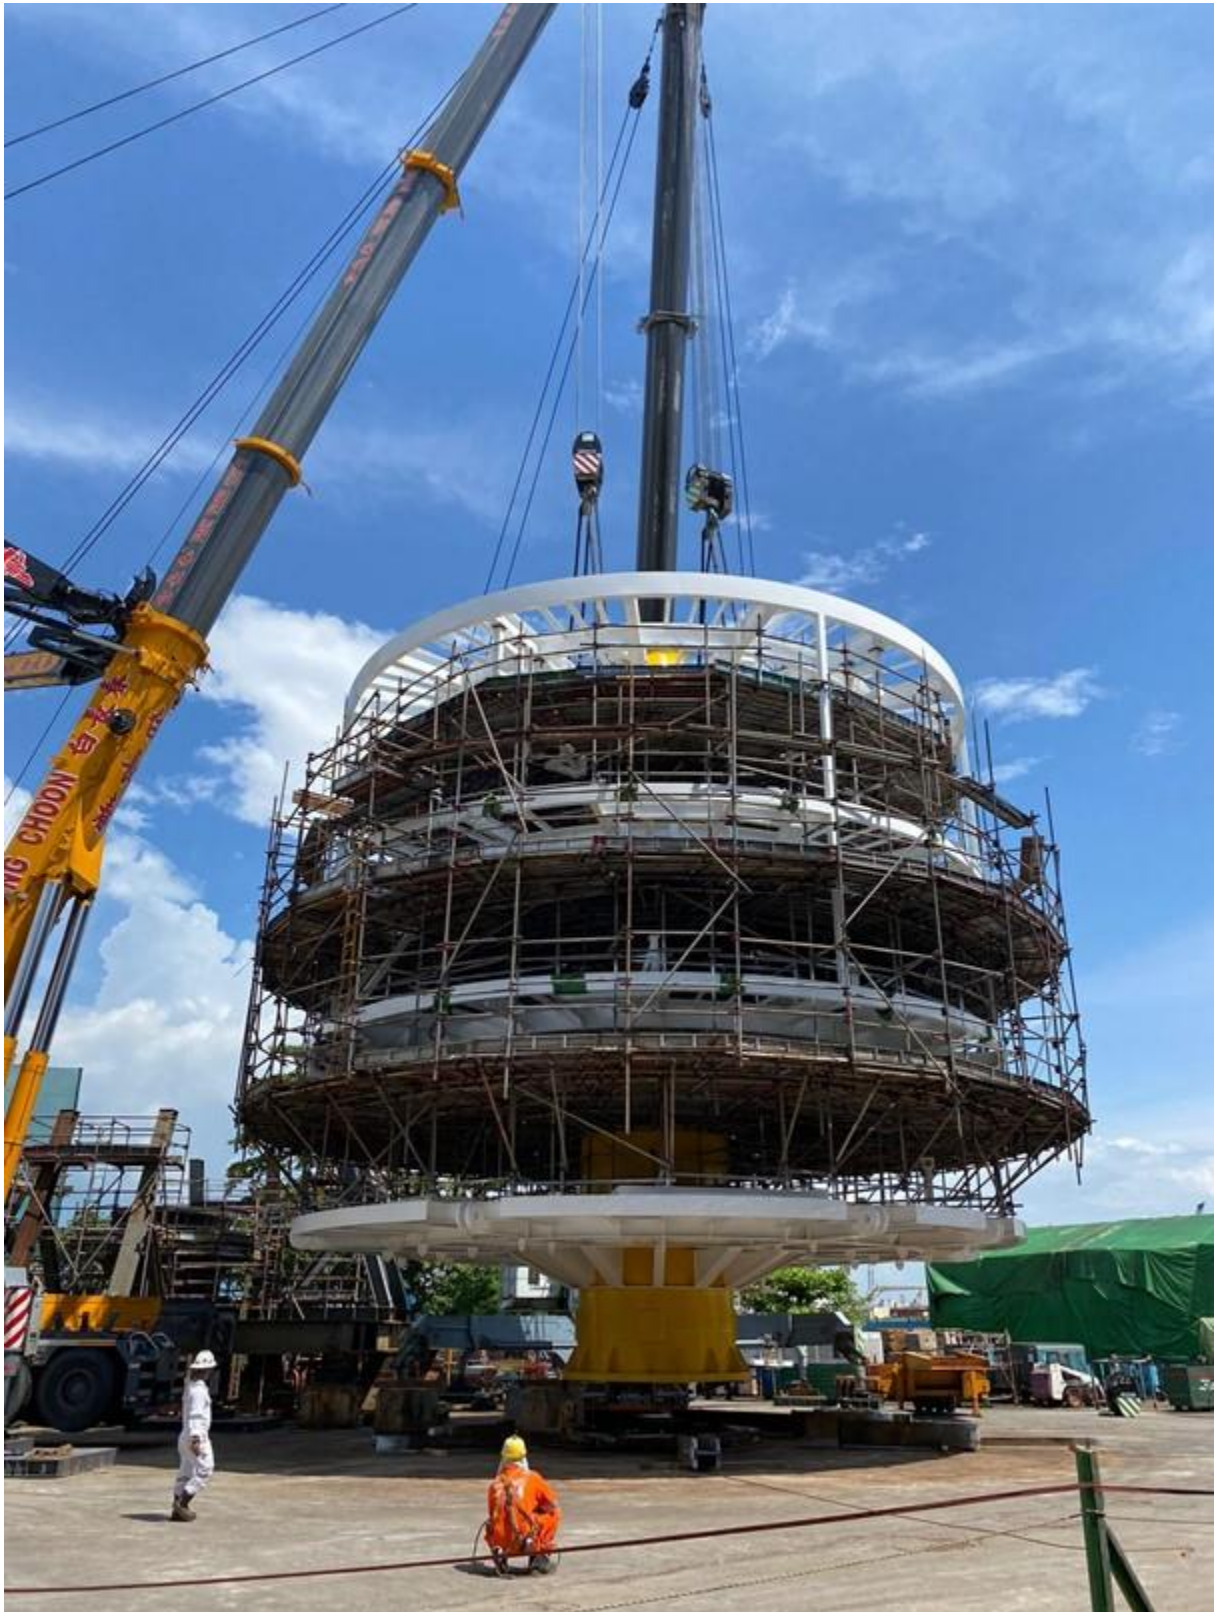
**Figure 3-22 View of the Geo-stationery module of Turret at Dynamac (not visited)**

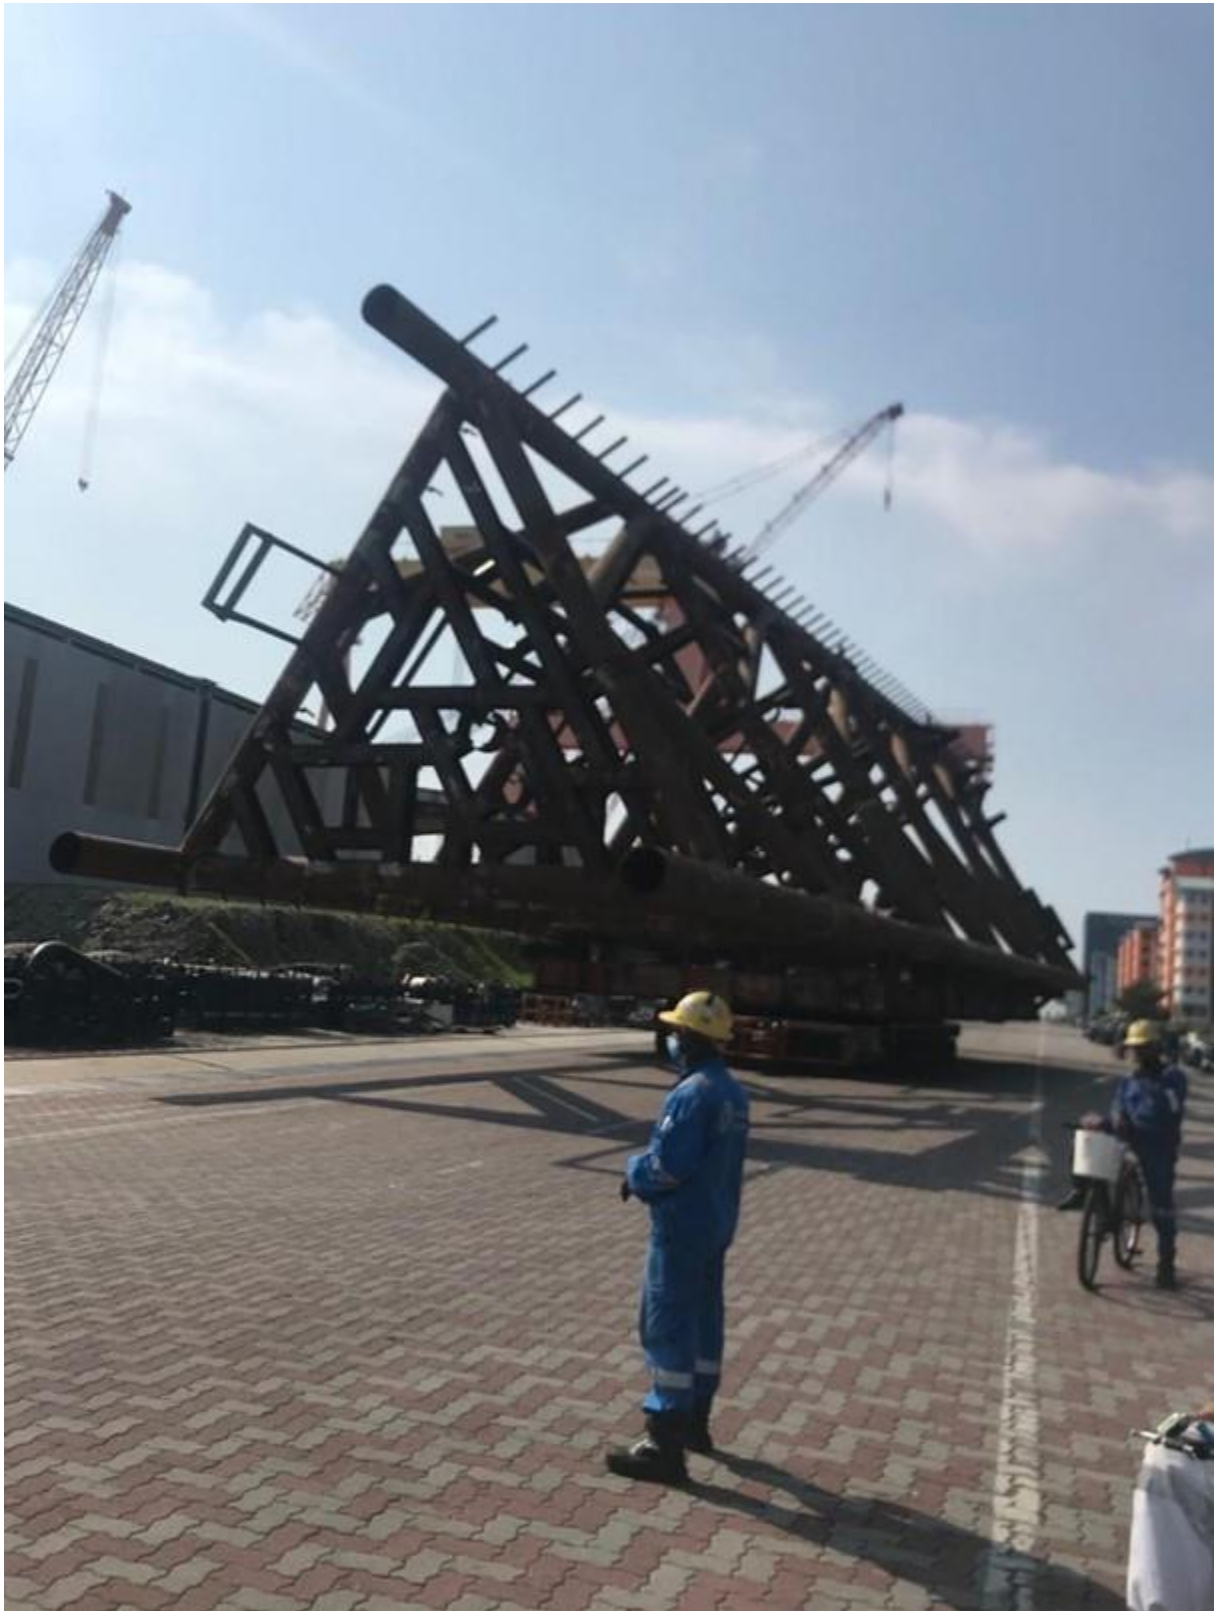
**Figure 3-23 The flare tower under fabrication at Sembcorp**
